Road & Railroad Crossing Inventory Mauvais & Big Coulee

**Bureau of Reclamation
Dakotas Area Office**

September 1999

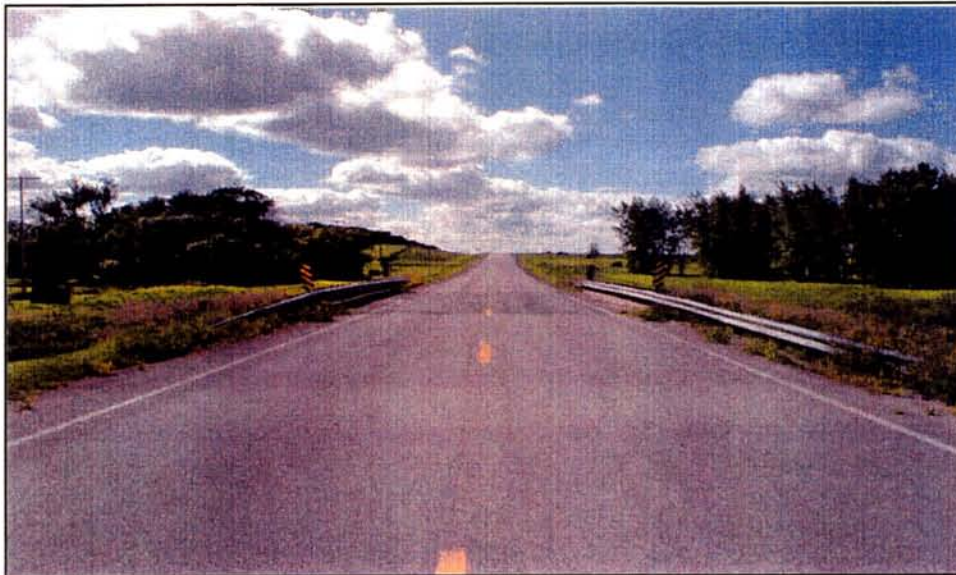
B10 Center of bridge looking west, in good condition, 32' wide & 64' long, Section 31 & 6, T159 & 160N, R67W, N 597175.87, E 2275775.10, Elevation 1558.0 @ center of bridge & N.D. Hwy. 66.

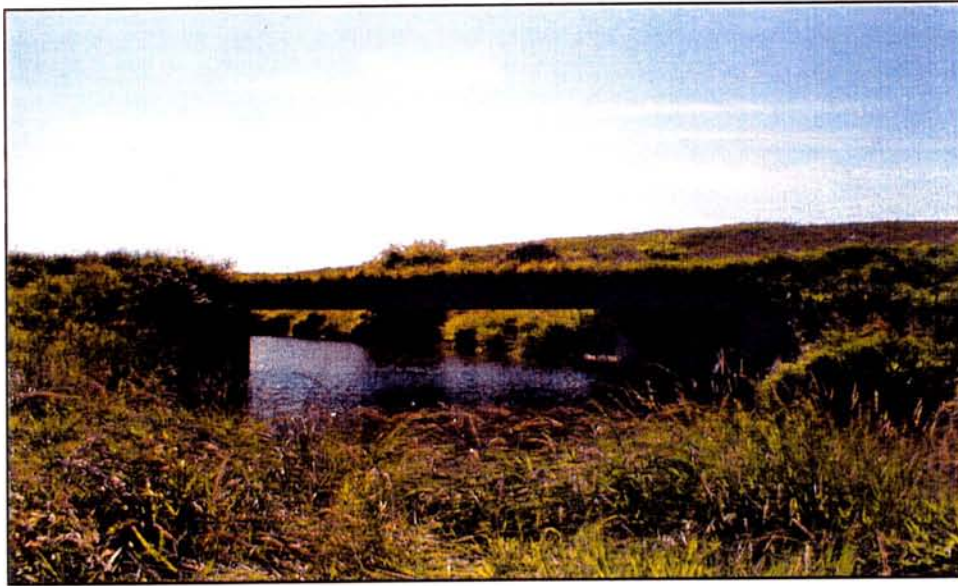
B11 Upstream side of concrete bridge, in good condition, 4.8 feet of water, (8-19-99), Section 19 & 30, T160N, R67W, N 607764.04, E 2276065.88, Elevation 1571.5 @ ∇ of coulee.

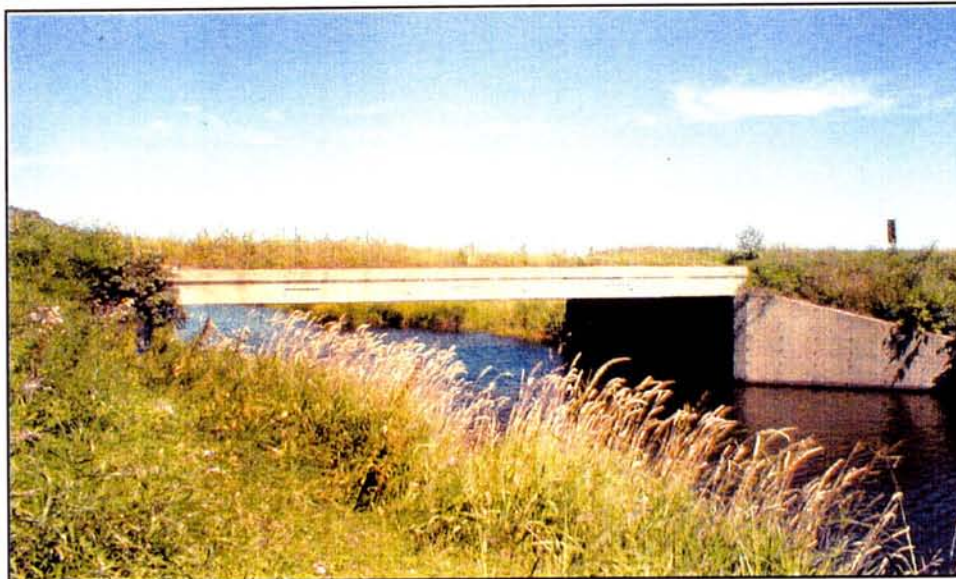
B11 Downstream side of concrete bridge, in good condition, 5.6 feet of water, (8-19-99), Section 19 & 30, T160N, R67W, N 607739.03, E 2276066.58, Elevation 1570.8 @ ∇ of coulee.

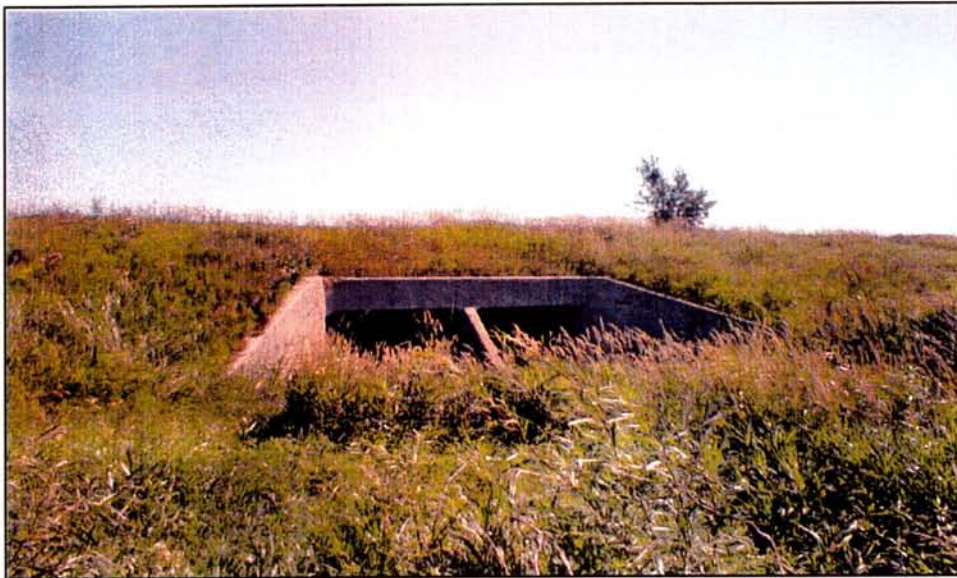
B11 Center of bridge in good condition, looking west, 25.7' wide & 36' long, Section 19 & 30, T160N, R67W, N 607751.23, E 2276066.49, Elevation 1585.1, @ center of bridge, top of gravel.

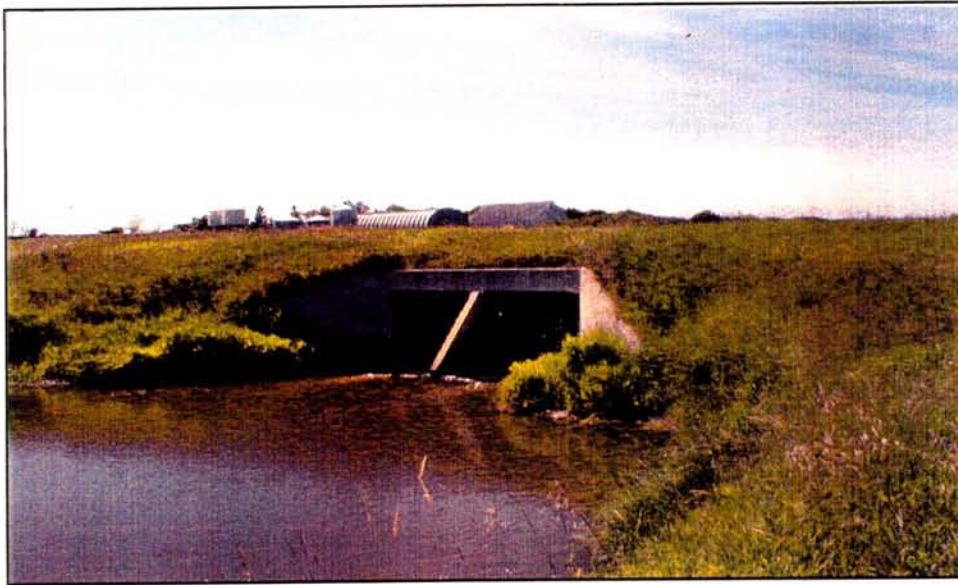
B12 Upstream side of double cell 7 foot high box culvert, in good condition, 0.3 foot of water, (8-19-99), Section 24 & 19, T160N, R67W & R68W, N 609347.395, E 2275034.76, Elevation 1579.2 @ center of coulee.

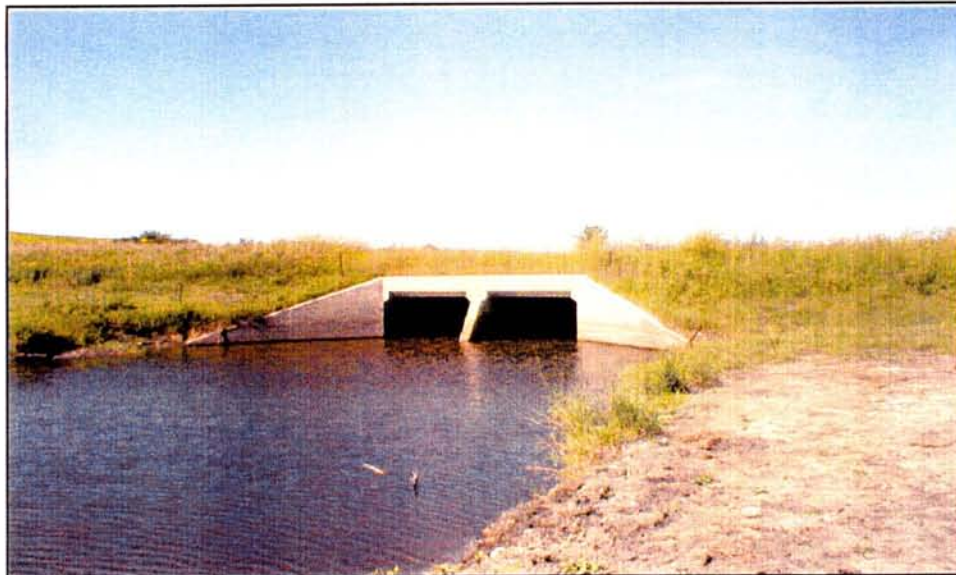
B13 Upstream side of double cell box 8' culvert, in good condition, 2.6 feet of water (8-19-99), Section 13 & 24, T160N, R68W, N 613022.80, E 2273190.59, Elevation 1583.9 @ ∇ of coulee.

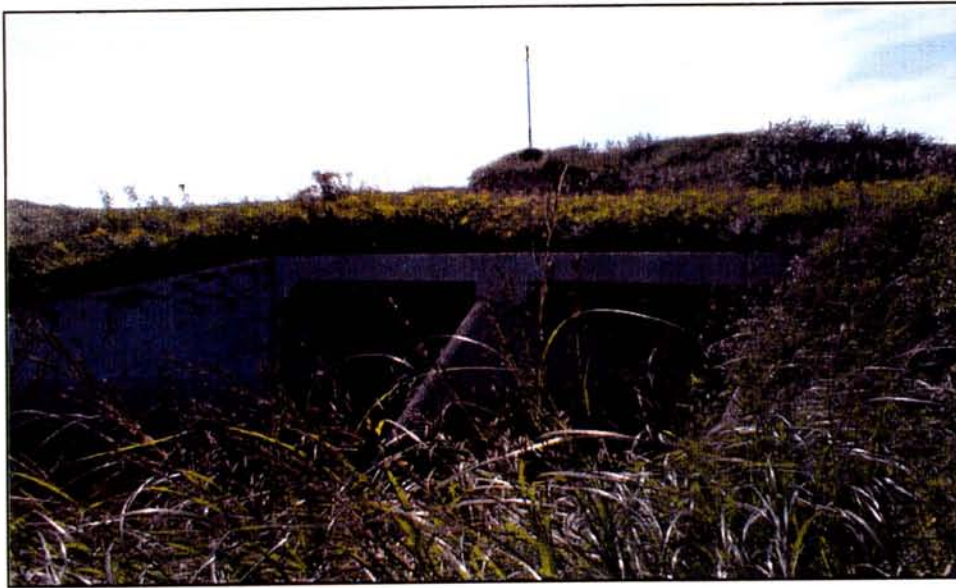
B14 Upstream side of double cell 9 foot box culvert, in good condition, 1.9 feet of water (8-19-99), Section 1 & 2, T160N, R68W, N 626600.10, E 2269511.25, Elevation 1614.2 @ ∇ of coulee.

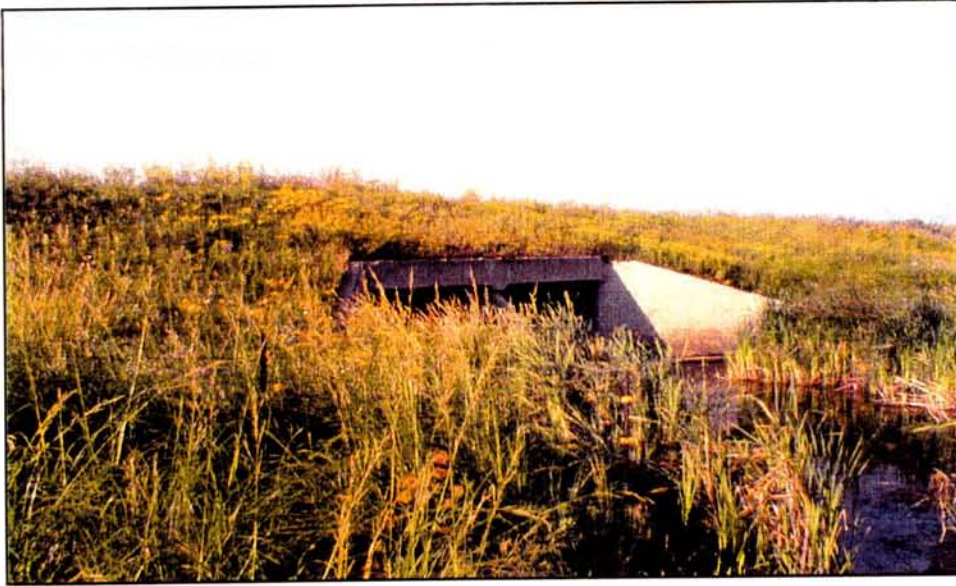
B14 Center of FAS road crossing of 53' wide & 19.5' long box culvert, in good condition, looking north, Section 1 & 2, T160N, R68W, N 626585.97, E 2269533.71, Elevation 1627.4 @ center of road crossing, top of gravel.

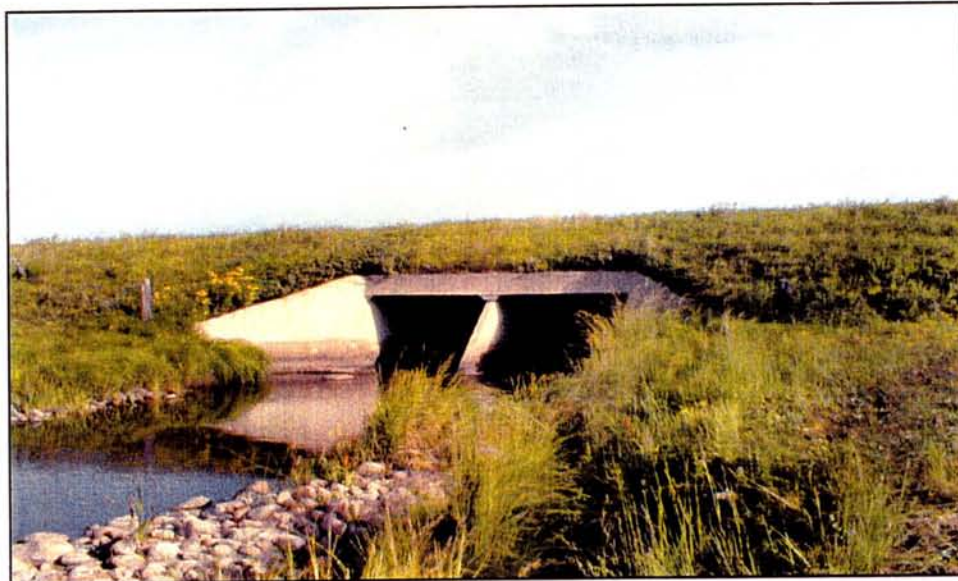
B15 Upstream side of double cell 7 foot box culvert, in good condition, 0.2 foot of water (8-20-99), Section 31 & 2, T160 & 161N, R68W, N 628771.95, E 2269075.93, Elevation 1620.6.

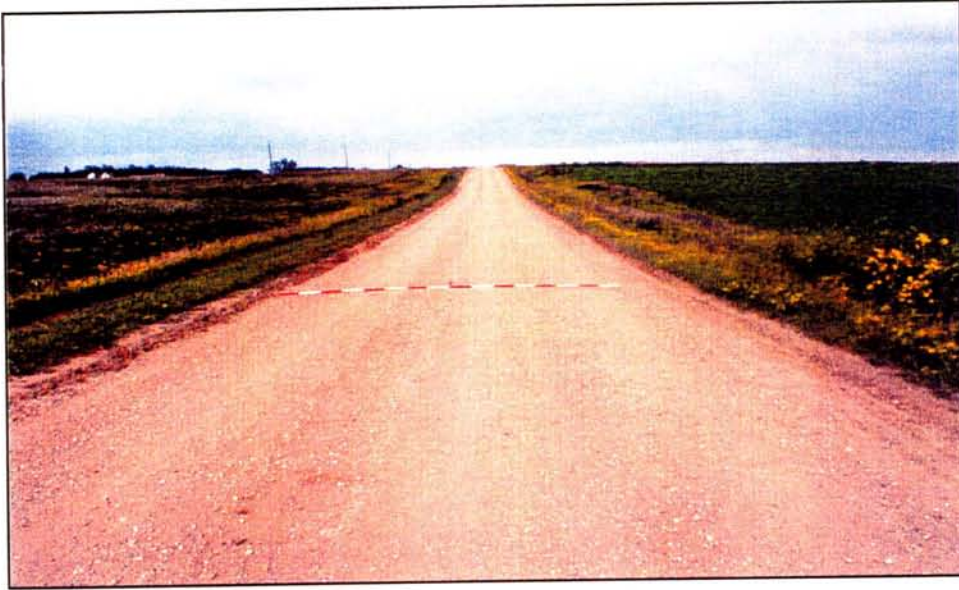
B15 Downstream side of double cell 7 foot box culvert, in good condition, 0.2 foot of water (8-20-99), Section 31 & 2, T160 & 161N, R68W, N 628696.38, E 2269077.91, Elevation 1620.6.

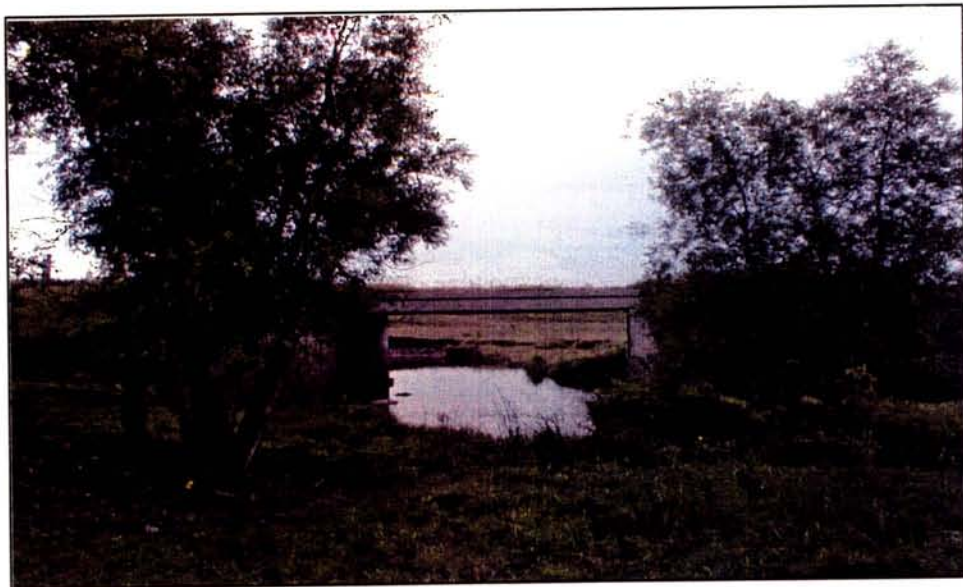
B15 Center of FAS road at 78' wide & 22' long box culvert, in good condition, looking west, Section 31 & 2, T160 & 161N, R67 & 68W, N 628730.54, E 2269079.71, Elevation 1636.8 @ center of road crossing, top of gravel.

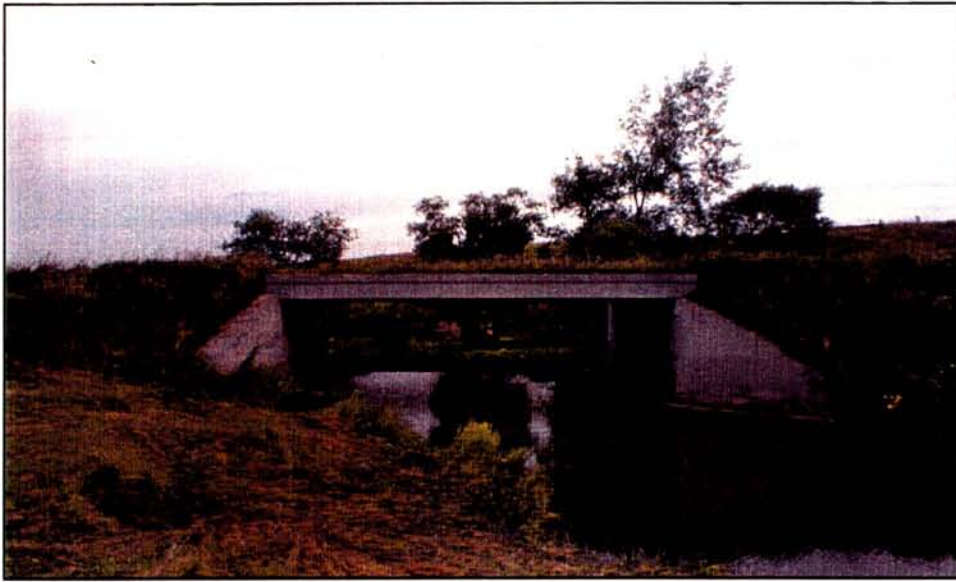
B16 Upstream side of concrete bridge, in good condition, 3.2 feet of water (8-20-99), Section 30 & 31 , T161N, R67W, N 634001.33, E 2267896.40, Elevation 1632.0 @ Φ of coulee.

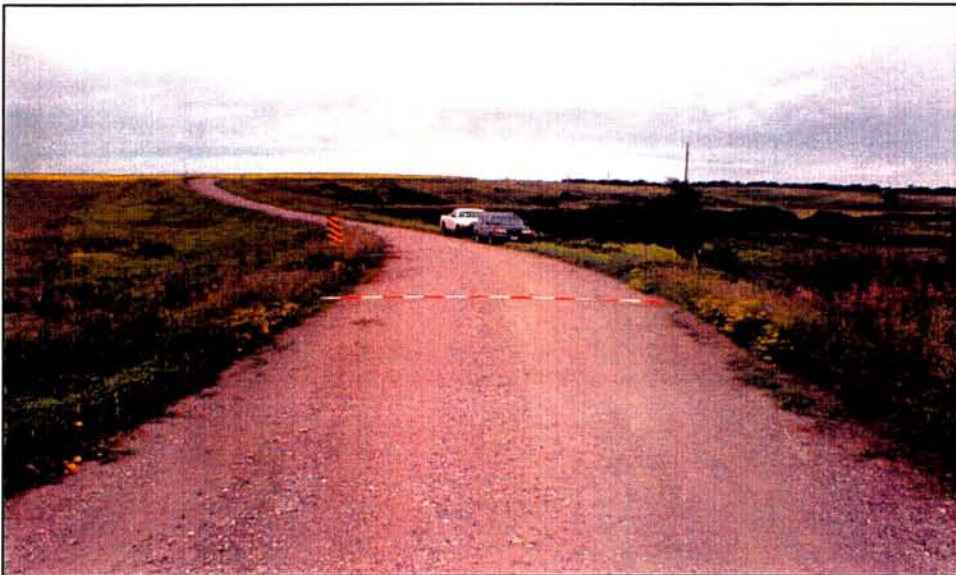
B16 Downstream side of concrete bridge, in good condition, 2.8 feet of water (8-20-99), Section 30 & 31, T161N, R67W, N 633975.66, E 2267896.38, Elevation 1632.3 @ Φ of coulee.

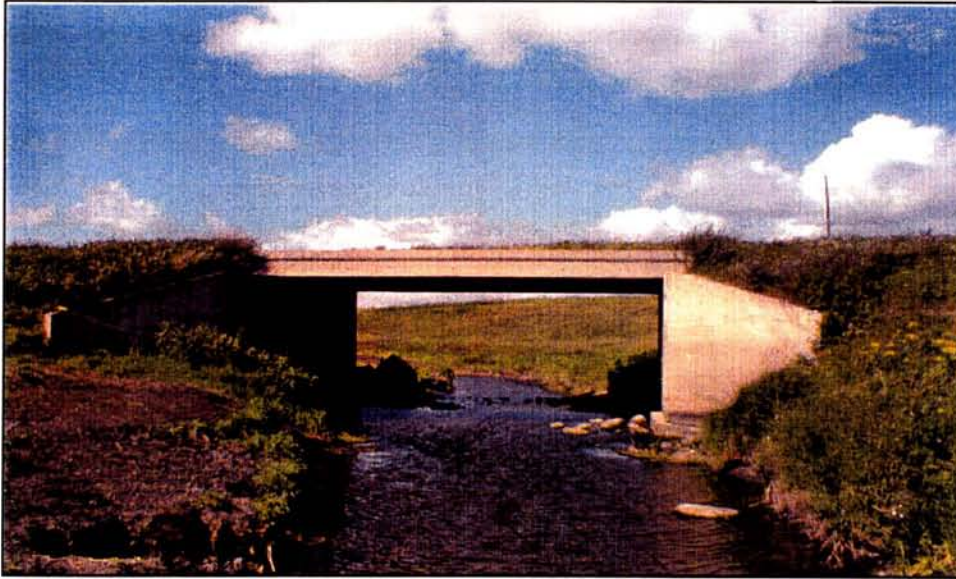
B18 Upstream side of concrete bridge, in fair condition, 0.4 foot of water (8-23-99), Section 14 & 23, T161N, R68W, N 644493.07, E 2261322.32, Elevation 1665.9 @ Φ of coulee.

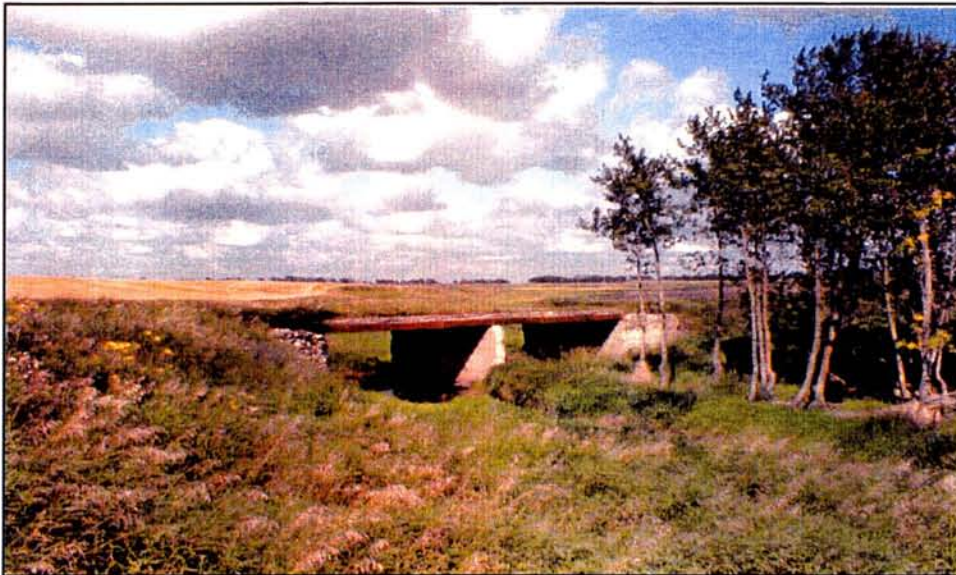
B19 Upstream side of concrete bridge, in fair condition, 4.2 feet of water (8-23-99), Section 11 & 14, T161N, R68W, N 649692.15, E 2256206.44, Elevation 1685.9 @ ∇ of coulee.

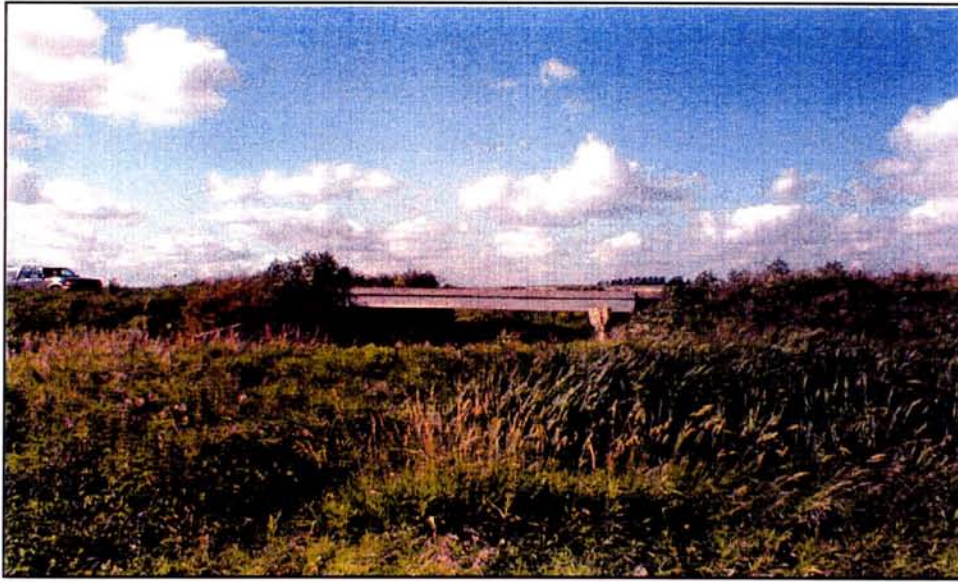
B20 Upstream side of concrete bridge, in fair condition, 4.2 feet of water (8-23-99), Section 3 & 10, T161N, R68W, N 654919.44, E 2252191.87, Elevation 1704.0 @ Φ of coulee.

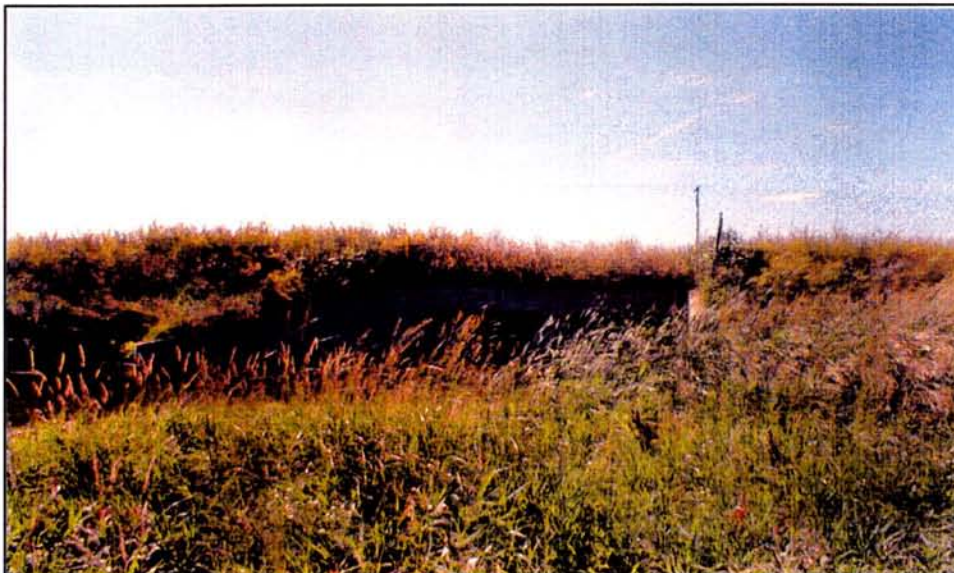
B21 Upstream side of double cell 8' high box culvert, in good condition, 3.0 feet of water (8-24-99), Section 3 & 4, T161N, R68W, N 656186.17, E 2250702.14, Elevation 1710.8 @ ∇ of coulee.

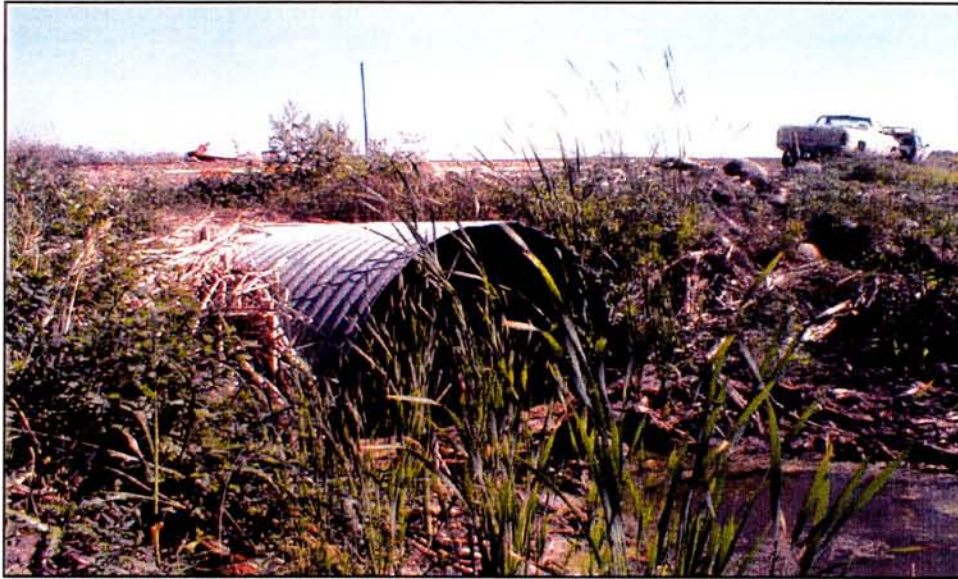
B22 Upstream side of 36" CMP', in good condition, looking from south to north, 1.6 foot of water, (8-24-99), Section 1 & 6, T161N, R69 & 68W, N 655635.48, E 2234918.50, Elevation 1749.2 @ invert of 36" CMP.

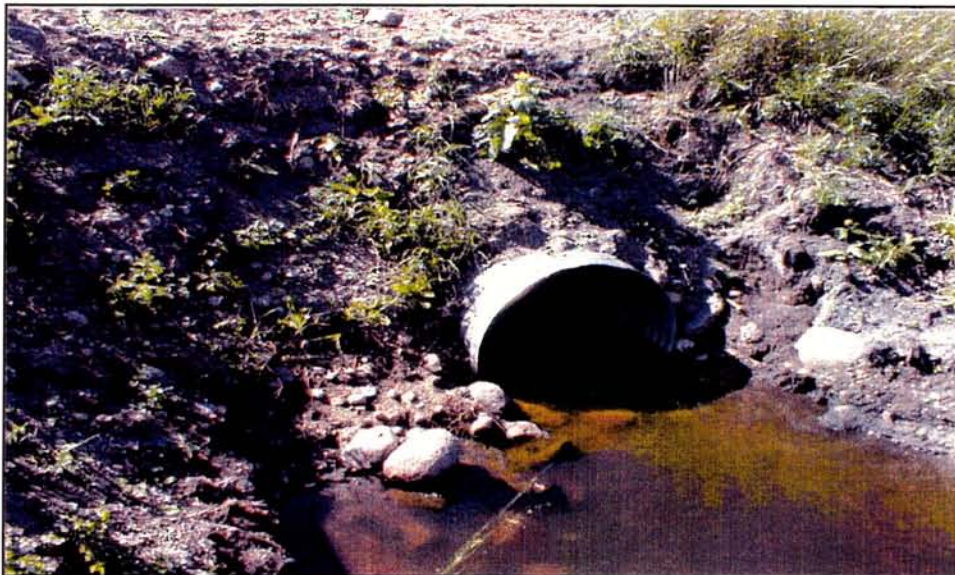
B22 Upstream side of 54" CMP, in good condition, no water, (8-24-99), Section 1 & 6, T161N, R69 & 68W, N 655652.40, E 2234918.24, Elevation 1750.2 @ invert of 54" CMP.

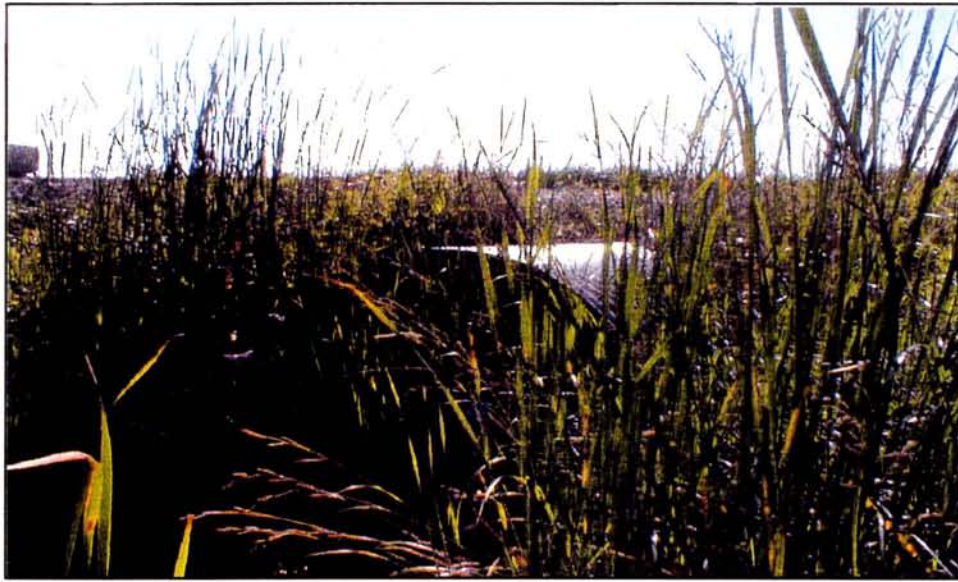
B22 Downstream side of 36" CMP, in good condition, 0.9 foot of water, (8-24-99), Section 1 & 6, T161N, R69 & 68W, N 655635.83, E 2234957.57, Elevation 1749.4 @ invert of 36" CMP.
